Manhole Inspection Summary

Manhole # S29K__004MH

Insp Date: **11/16/08 11:12 AM**

Location Address: **667 Portland St**

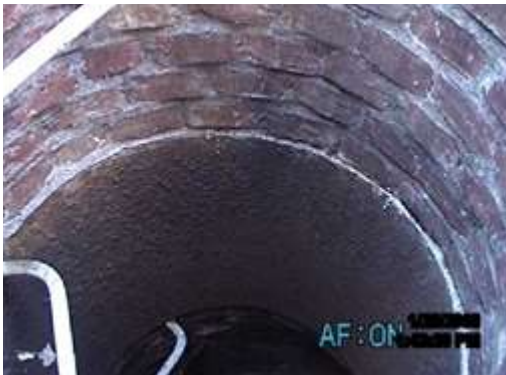
Miscellaneous

past infiltration corbel/barrel joint

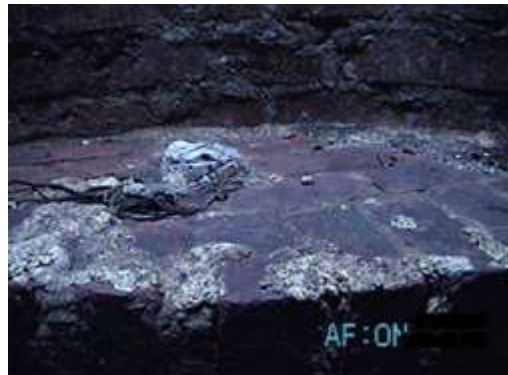
Miscellaneous

debris on bench

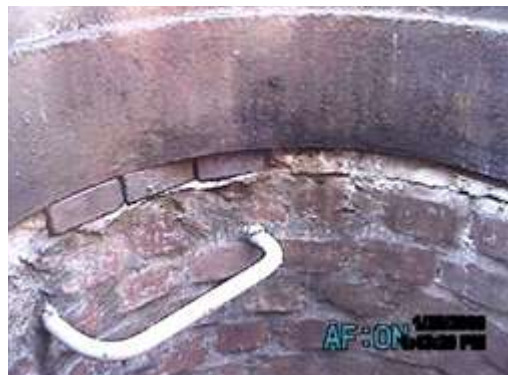
Defect 2

Frame Offset: **0** (in.) Condition: ☐ Sound ☐ Cracked ☒ **Leaks**

missing mortar/ frame/lid infiltration

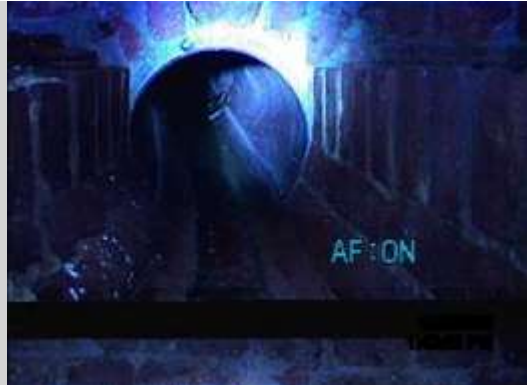
12 O'Clock Outflow

Pipe Height: **12** (in.) Rod and Bar (Angled)
Pipe Material: **Clay** ☐ Pipe Lined
Invert Depth: **8.90** (ft.) Flow Characteristics: **None**
Deposits: ☒ None ☐ Mud ☐ Sludge ☐ Debris ☐ Grease
Silt Depth: **0** (in.) Deposits Extent:
Infiltration: **None** Pipe Seal Cond: **Sound**

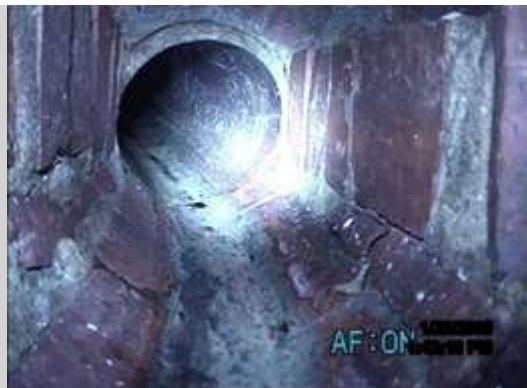
5 O'Clock Inflow

Pipe Height: **12** (in.) Rod and Bar (Angled)
Pipe Material: **Clay** ☐ Pipe Lined
Invert Depth: **8.79** (ft.) Flow Characteristics: **None**
Deposits: ☒ None ☐ Mud ☐ Sludge ☐ Debris ☐ Grease
Silt Depth: **0** (in.) Deposits Extent:
Infiltration: **None** Pipe Seal Cond: **Sound**

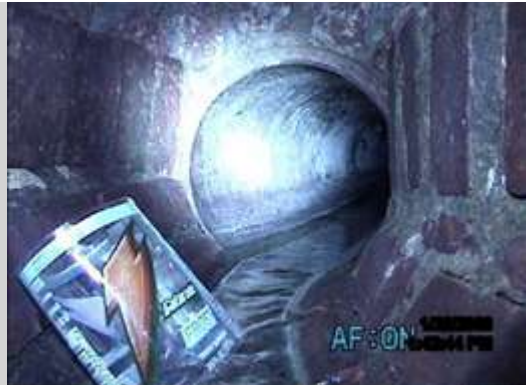
8 O'Clock Inflow

Invert Depth: **8.72** (ft.) Flow Characteristics: **Slow**

Infiltration: **None** Pipe Seal Cond: **Sound**
